Streambank Protection Guidelines

Vegetation is nature's way of protecting a streambank.

Prepared by U.S. Army Engineer Waterways Experiment Station, Vicksburg, Mississippi 39180 Written by: Malcolm P. Keown,

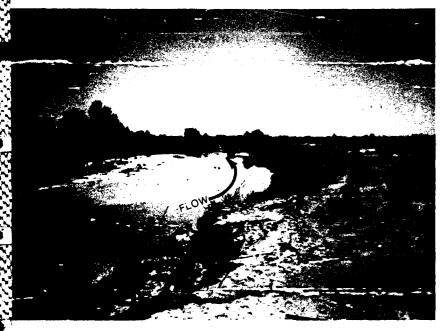
Serious streambank erosion is occurring on the right bank of this bend, while a point bar is building up on the left bank.

As streamflow moves through a bend under normal flow conditions, the velocity increases toward the outside of the bend (or cut bank) increasing the tractive force to as much as twice that in a straight reach of the channel upstream or downstream from the bend. As a result erosion can occur along much of the cut bank, often extending

a short distance downstream from the end of the bend. On the inside of the bend the stream velocity decreases allowing suspended sediments to deposit and build up a point bar. Sharply curved bends are more likely to experience erosion along the cut bank than gradually curved bends. During flood flow the path of maximum velocity moves across the channel against the point bar. often removing material that was deposited during normal flow conditions.

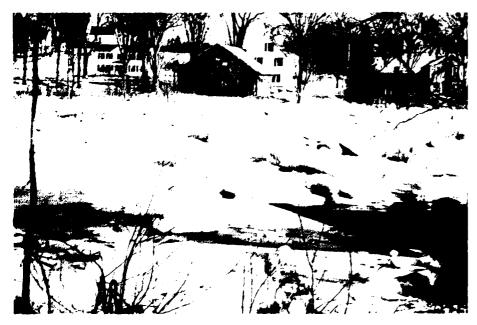
Debris can cause streambank erosion due to abrasion or impact.

to the streambanks is largely determined by whether the banks are still frozen or have begun to thaw. Frozen banks generally sustain little soil loss; however, structures such as boat docks, as well as trees and other vegetation, may be stripped away from the frozen banks by the impact of the ice chunks or pressure buildup from an ice jam. If the chunks of pack ice pass through a channel where the banks have already thawed, severe bank erosion can occur, mainly due to grinding of the ice against the streambank (abrasion). Debris, like ice, can cause streambank erosion by either abrasion or impact. The most common debris found in streams are the remains of fallen trees.

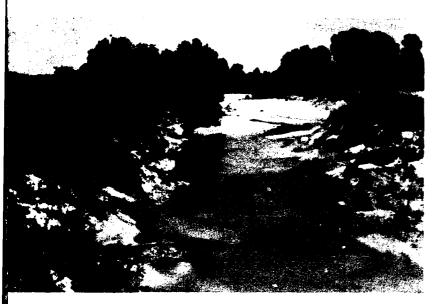
Bed scour in effect raises the height of top bank which in turn may lead to bank failure.

As the bed of a channel is scoured out by passing streamflow, the height of top bank above the bed increases. The bank may fail if its height continues to increase (see photo next page). Erosion of a bank face can increase shear stress in two ways: by undercutting the toe that buttresses the bank or by steepening the bank slope.

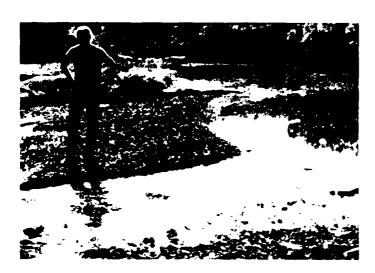
Pilot channel eroding point bar (left). Concrete check dam (right).

A check dam should be placed bank to bank across the scouring channel bed and located downstream from the rough water or waterfall. (NOTE: Check dams can also be placed upstream from the waterfall or rough water to intercept the headcut; however, this solution should not be considered without the benefit of professional assistance.) The net effect will be to reduce the stream velocity and to encourage sediment deposition which will build up the scoured bed. Check dams can be constructed from stone, concrete, sand-cement bags, treated timber, metal, etc. The toe of the check dam should be well protected to prevent the structure from being undermined. Further, the ends of the dam should be rooted into the banks so the structure cannot be flanked. Streambanks immediately downstream from a check dam sometimes show a tendency to erode. These banks should be watched after the dam is completed. Check dam construction can be very expensive;

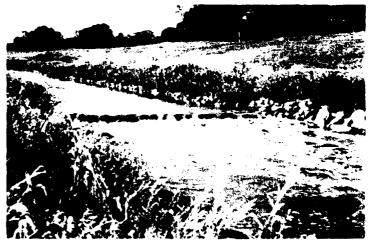
The bed and lower bank of this channel were lined with manufactured precast concrete blocks to retard active bed scour. Openings in the blocks allow grass to grow through (left). Properly selected grass species can provide effective streambank protection (right).

Vegetation is generally divided into two broad categories: grasses and woody plants (trees and shrubs). The grasses are less costly to plant on an eroding bank above the toe and require a shorter period of time to become established. Woody plants offer greater protection against erosion because of their more extensive root systems; however, under some conditions the weight of the plant will offset the advantage of the root system. On very high banks, tree root systems do not always penetrate to the toe of the bank. If the toe becomes eroded, the weight of the tree and its root mass may cause a bank failure.

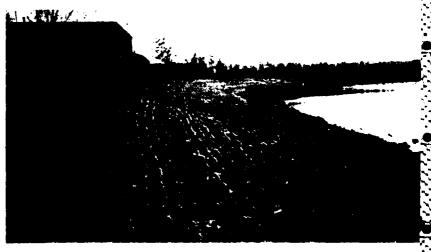
Completed gabion revetment made from prefabricated baskets. Note support apron (arrow) extending from toe of structure.

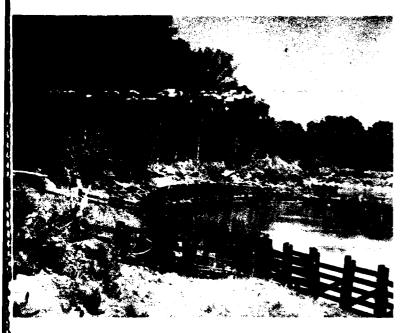
Wooden fence constructed along eroding streambanks. Note sediment deposition behind the fenceline and the tie-back fences between the fence and bank. If the fence is long, tie backs are needed to minimize flow between the fenceline and bank (left). Double row fence (right). Fences are most successful as a bank protection method on streams with heavy sediment loads.

Many types of local materials have been used for fence construction. Wood, used rails, pipe, steel beams, etc., are suitable as fence posts. The same materials can be used to back brace the fence. Wood and wire are generally used for the fencing material. If wire is used it should be strong enough to withstand the expected current load of water and debris. Field fencing and welded-wire fencing are effective against heavy and medium current loads, while chicken wire is suitable for lighter loads. Double row fences are sometimes constructed to provide additional resistance to stream attack with the gap between the fences filled with brush, hay, stone, or used tires.

- b. The ends of the fence should be tied into the bank at the upstream and downstream ends of the fenceline to minimize flow between the fenceline and the bank that could cause erosion. If the fence is long, tiebacks are needed at regular intervals between the fenceline and bank.

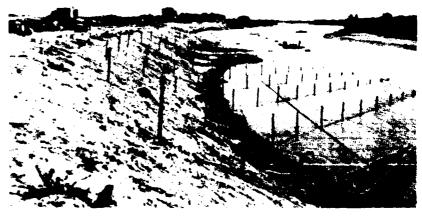
LEFT: Brush dike tied into bank with cable.

BELOW: Wire fence dike field. Note that the top of each fence post is guyed to the bottom of the fence post immediately upstream and that each fence line is tied into the bank.

Materials used to construct an impermeable dike ought to be heavy enough to stay in place and not be carried away by stream currents. If light materials must be used, such as brush, they should be well secured by weighting the material down and the dike should be tied into the bank with cable or chain.
